Patio Refurbishment & All Paving Maintenance

Case Study

Granite Driveway Entrance, Rochdale, Greater Manchester

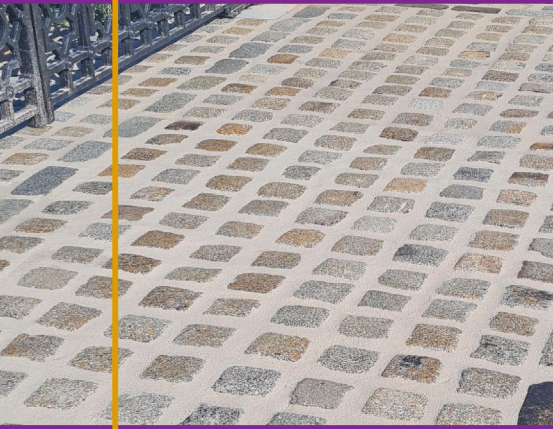
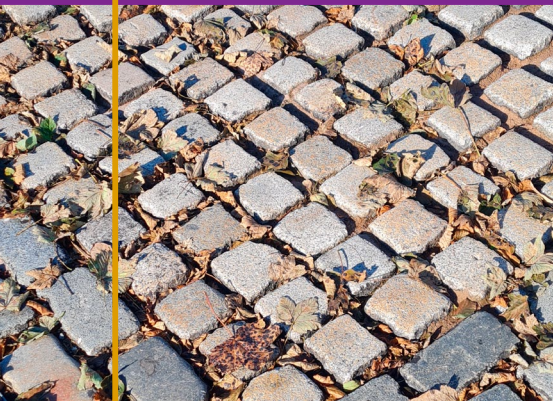
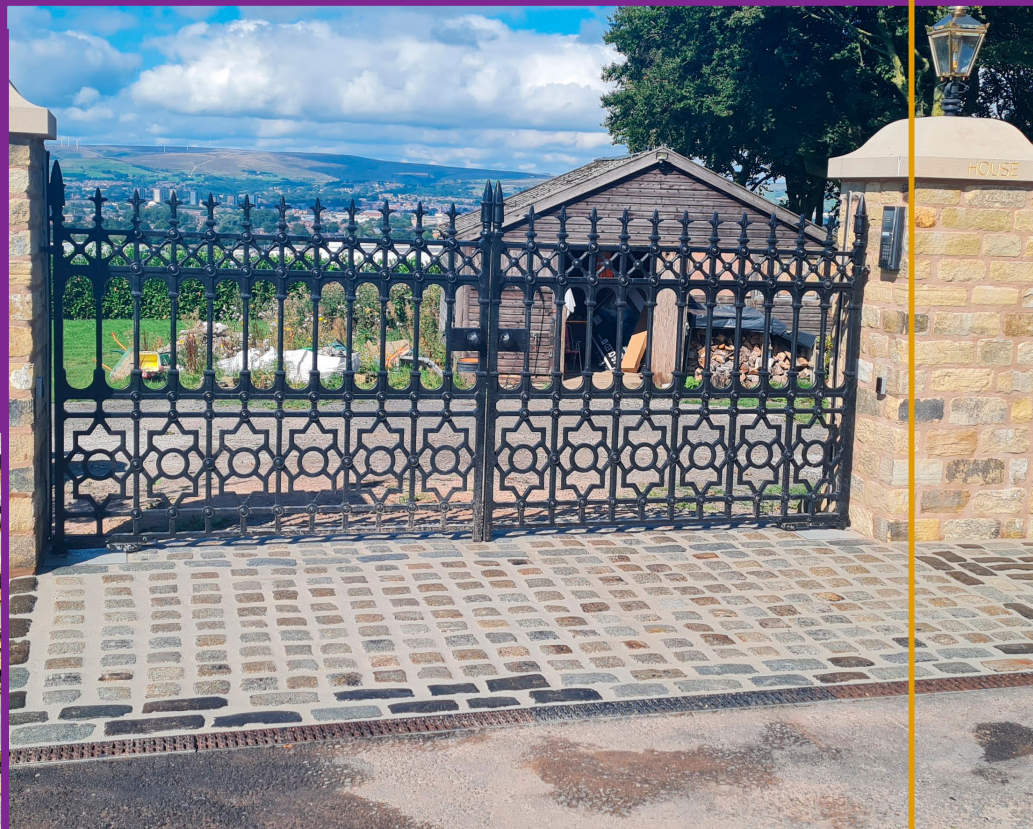
Specialist paving contractor, CR Services, was asked to provide a solution for the failed grouting in this domestic cobbled driveway, which is situated high in the hills around Rochdale. The property is on a private road that is open to the elements, and is also shared by two farms who use it for daily access. Consequently, it is driven over regularly by heavy traffic and farm machinery. The entrance to the property from the road is composed of natural granite cobbles, which had previously been grouted using a cement based mortar, that had proved to be nowhere near up to the job and had failed.

This was no problem for CR Services, who advised replacing the failed grouting with Gftk's vdw 850+, a high performance, non-staining, 2-part epoxy paving mortar from NCC Streetscape. This is extremely tough and durable, has resistance to de-icing salts and freeze/thaw and is well capable of withstanding the heavy loading from such traffic.

The crew from CR Services raked out the old failed jointing and associated debris, and then applied Gftk's vdw 850+, finishing the job in double quick time. The owner is delighted with his refurbished driveway entrance that is now able to stand up to the traffic including heavy farm equipment on the road.
