# Patio Refurbishment & All Paving Maintenance

### Porcelain Patio Refurbishment, Croston, Lancashire

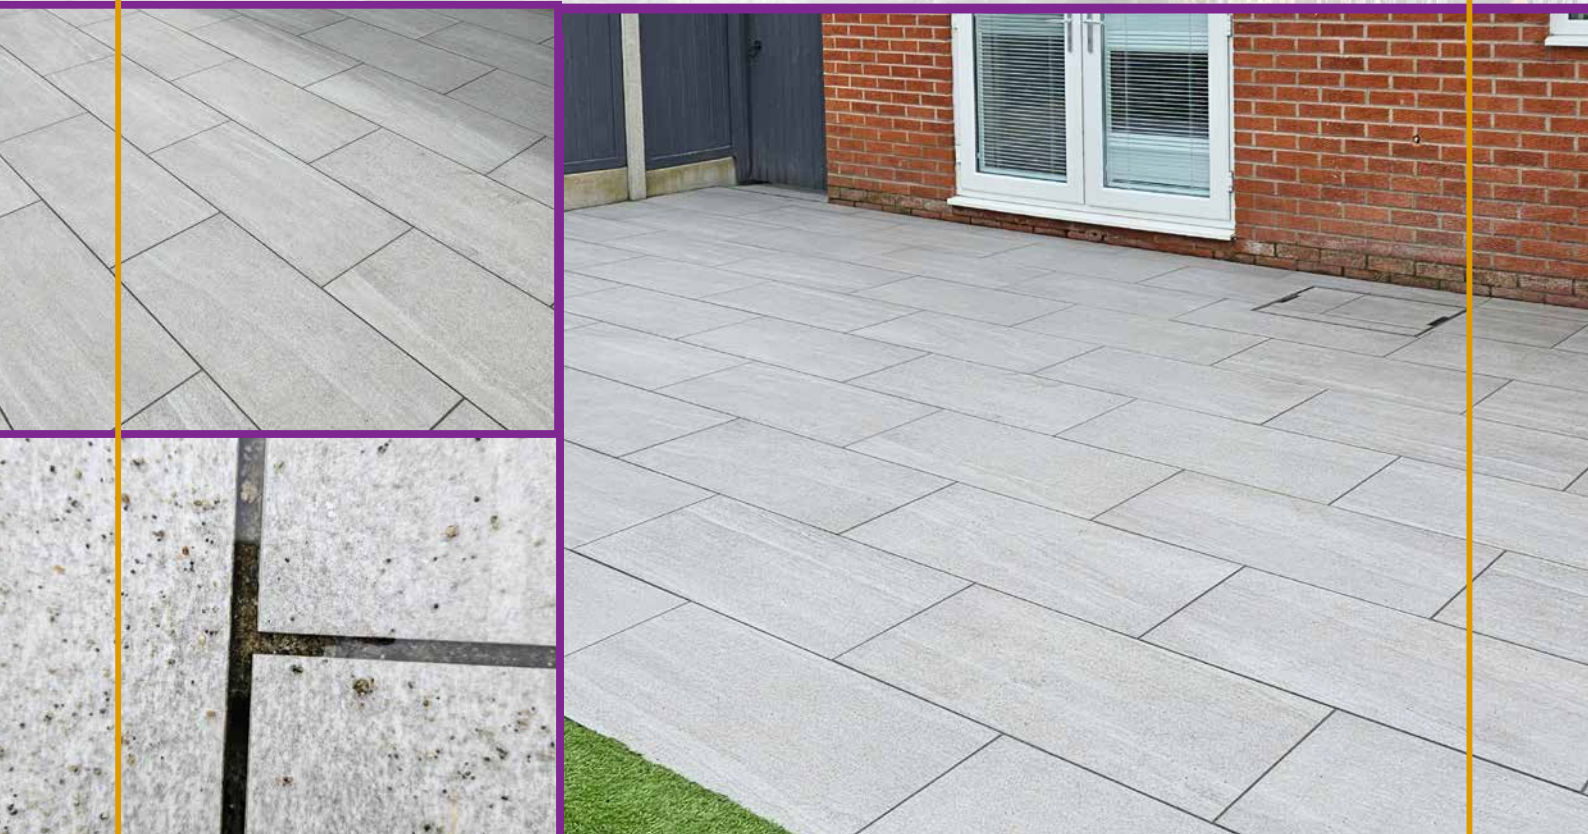
The owners of this property, in the picturesque village of Croston, in Lancashire, were desperate to find a solution to the problems they were encountering with their porcelain patio. It had only been down for two years and the pointing had already failed and been repointed twice, yet it was coming out again.

The patio had previously been pointed with typical single pack jointing compounds, which are not really suitable for jet-washing and use in the narrow joints commonly used with porcelain paving.

The solution from CR Services was to remove all the existing residual jointing compound, and replace the failed pointing with GftK vdw 815+, a high performance, 2-part epoxy paving mortar, that is stain free, fast and efficient to wet slurry apply. It is specifically designed for narrow joints, and importantly, can be safely jet-washed for ease of future maintenance.

CR Services also cleaned the patio with NCC Porcelain Aftercare cleaner to give an 'as new' look to the area, which the owners said was far better than when originally built and they were delighted!
