Patio Refurbishment & All Paving Maintenance

Case Study

Driveway Refurbishmnet, Preston, Lancashire

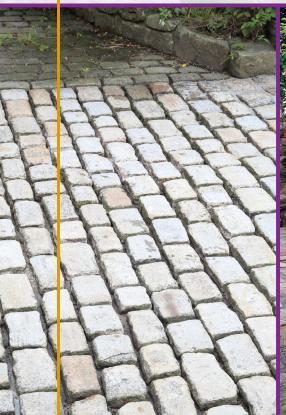
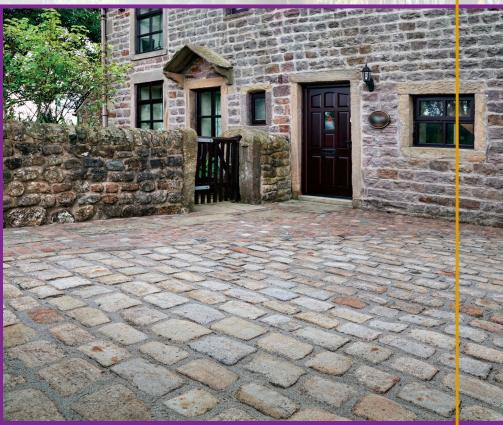
This private driveway in Preston, Lancashire is constructed with granite setts, and receives a lot of harsh exposure to de-icing salts from both passing traffic and also from being used for vehicle standing throughout the year. As a result the previous replacement cement joints were cracked, breaking up, and in places, lost altogether, causing damage to the stone bedding, further exacerbating the problems.

The team at CR Services removed all the failing cement joints and re-bedded any loose granite setts. The driveway was then cleaned using NCC Dirt & Grime Remover followed by new jointing with vdw-850+, which was completed quickly and efficiently. The homeowners were delighted with the finished result, knowing that their completed driveway was now fit for purpose, well into the future.
