Patio Refurbishment & All Paving Maintenance

Case Study

Indian Sandstone Patio, Sale, Cheshire

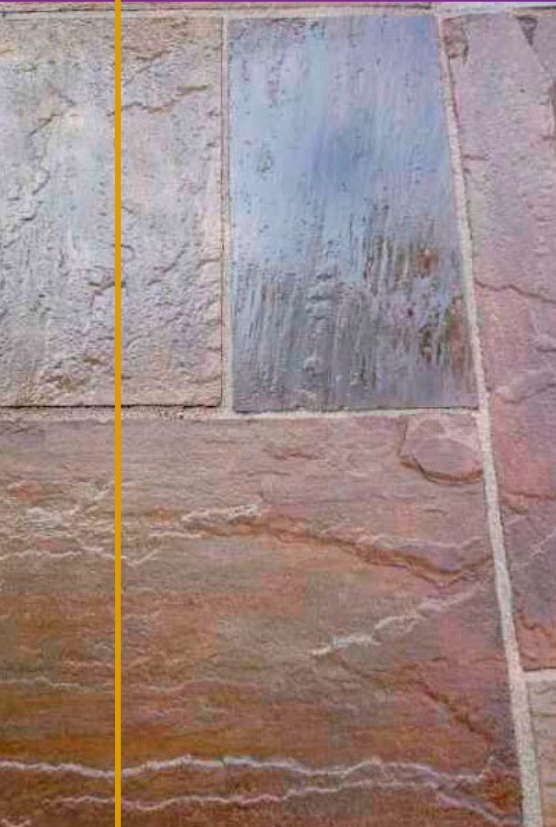
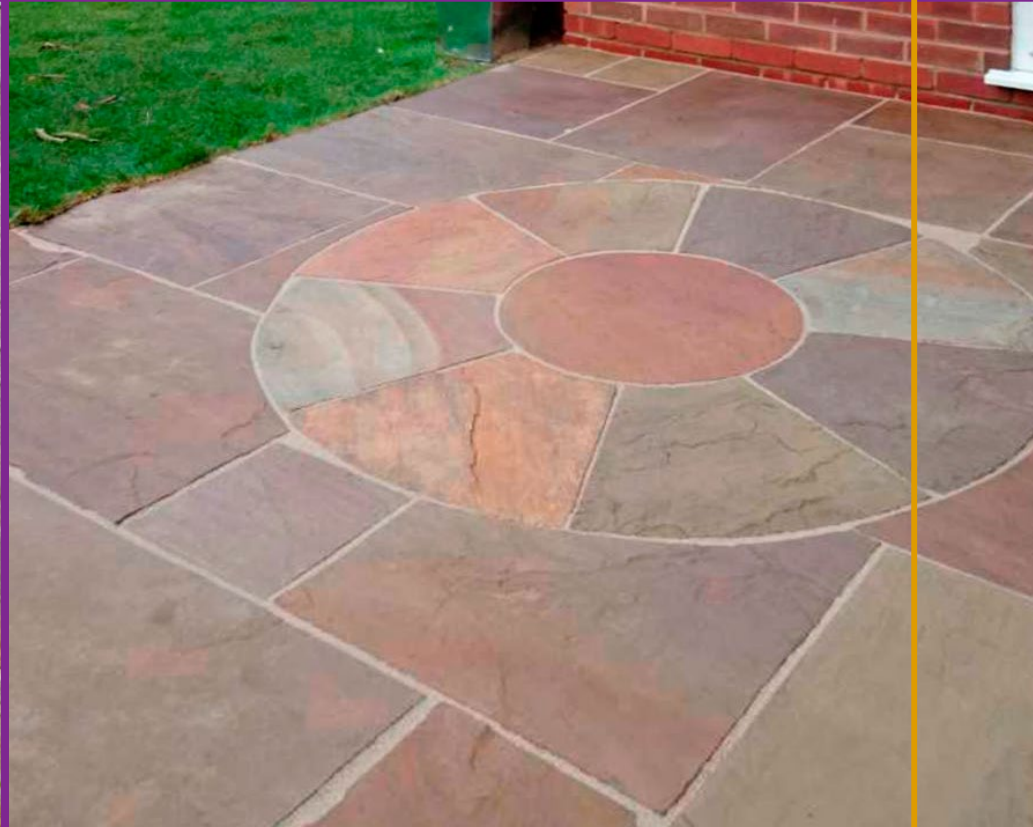
This well-loved and well used back garden patio includes a decorative circular feature, also created in the same natural Indian Sandstone. Unfortunately it had seen better days and was looking somewhat tired and dirty with the original sand and cement grout failing in several places.

CR Services were asked to come up with a solution and proposed that the old failed grout should all be completely removed and then the stones should be jet washed and professionally cleaned using NCC Black Spot & Green Growth Remover. The patio would then be re-grouted using GftK's vdw 850+, 2-part high performance jointing system from NCC Streetscape.

The end result, a patio that was not only as good as new but better for the long term, so impressed the homeowners that they booked CR Services to do a similar job on their driveway, safe in the knowledge that the high performance pointing system from NCC Streetscape is designed to handle the extra stresses caused by vehicular traffic.
