Patio Refurbishment & All Paving Maintenance

Case Study

Sandstone Patio & Pathways, Warrington, Cheshire

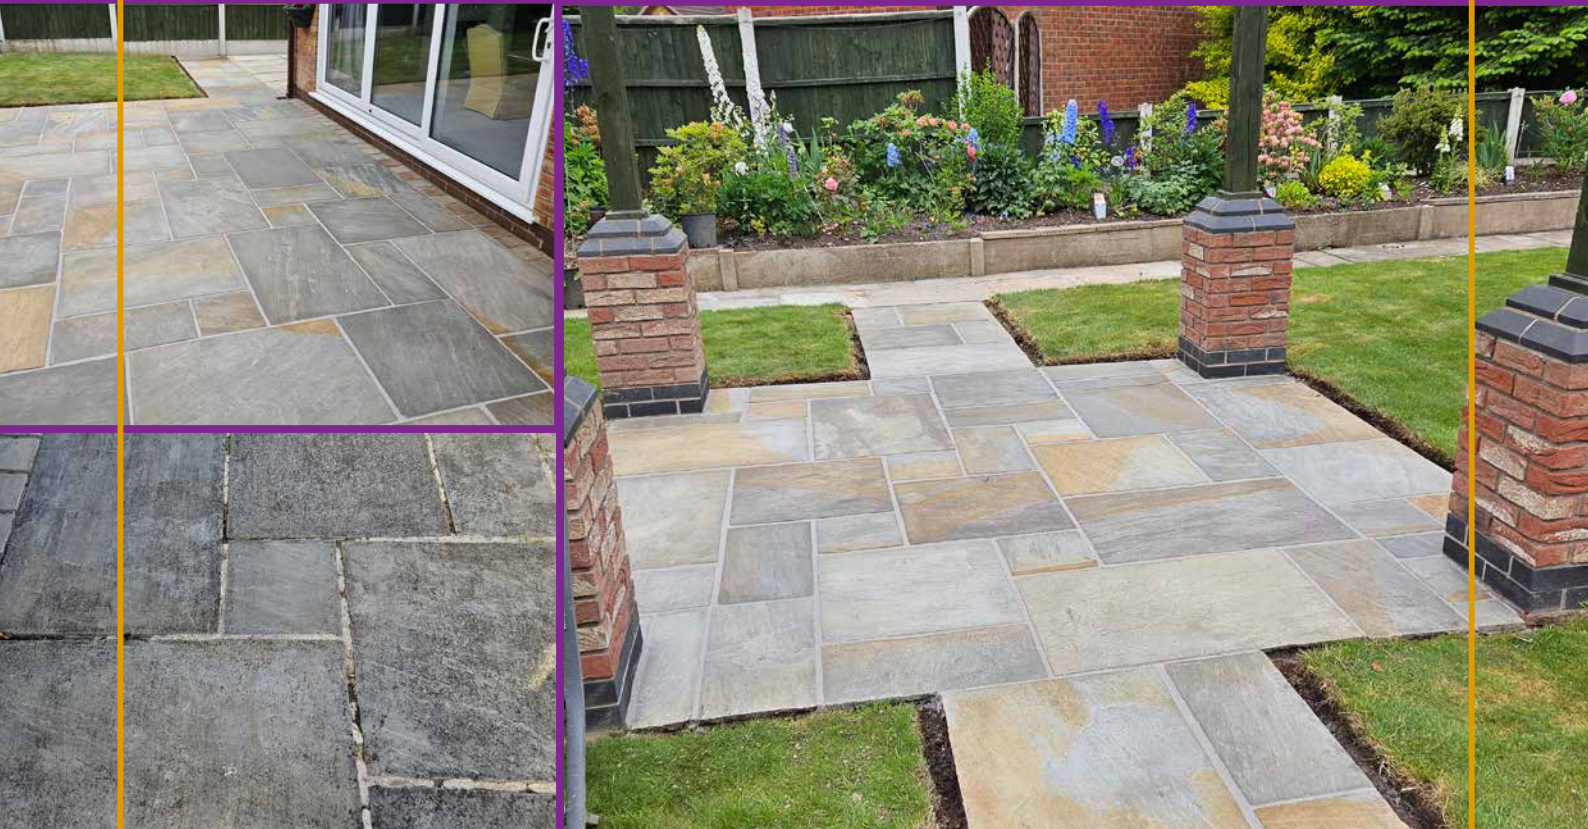
This large refurbishment project in Warrington comprised a traditional sandstone patio, plus pathways, and an ornamental brick and wood built gazebo area. These once attractive paved areas had only been laid around seven years ago but had now become unsightly because of cracked and failing sand and cement pointing mortar, together with dirt, grime, moss and lichen build-ups on the surfaces.

This was no problem to specialist paving contractors CR Services, who deal with such problems on a daily basis. They worked out a plan of action for the homeowners, and having been given the go-ahead, cut out the failing sand and cement mortar, jet-washed all surfaces and then applied NCC Black Spot & Green Growth Remover to clean up and remove the unsightly growths and dark staining deposits that had accumulated on the natural stone slabs.

The team from CR Services then re-pointed all areas with GftK vdw 850+ in natural colour. This is an extremely durable, 2-part epoxy based joint mortar, supplied by NCC Streetscape, to replace the failed cement mortar.
