# Patio Refurbishment and Garden Maintenance

### Sandstone Patio & Designer Circle, Skelmersdale, Lancashire

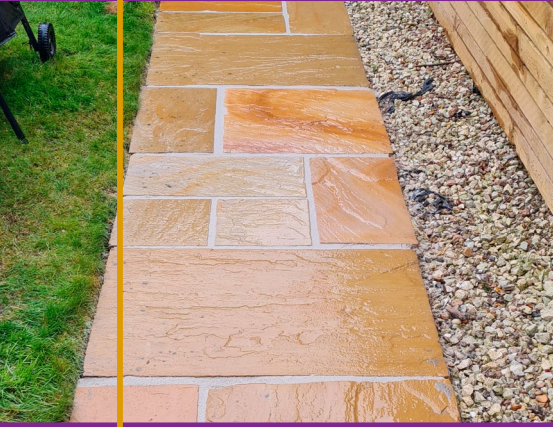
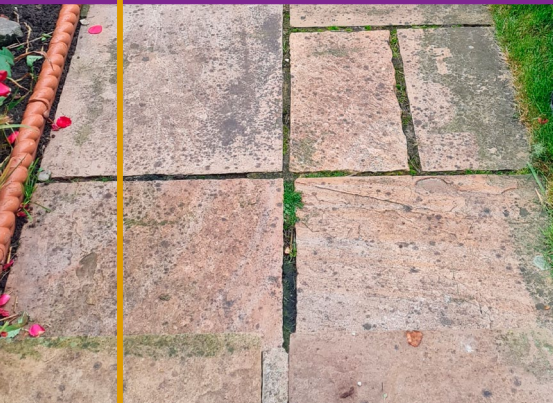
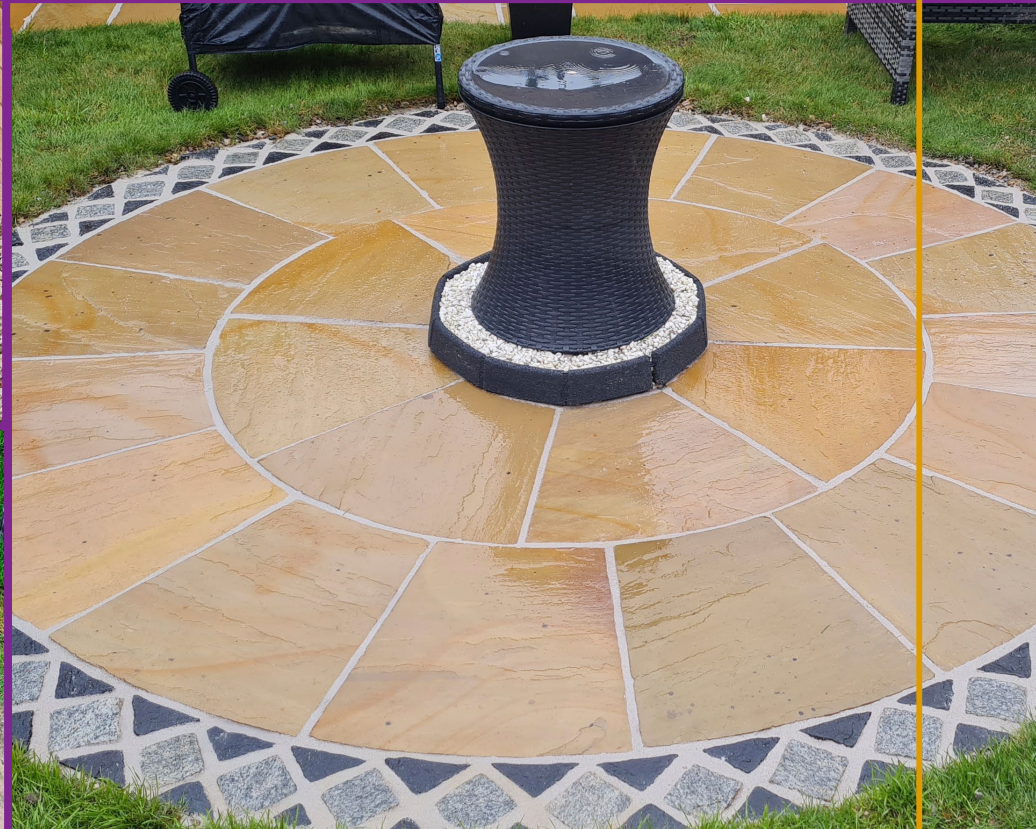
This refurbishment project at a private residence in Skelmersdale, Lancashire, comprised of natural sandstone patios and pathways, plus a once attractive, bespoke designer sandstone circle, complete with granite sett edging. These were all now looking sad and dirty, with cracked and failing joints throughout.

The team from CR Services jet-washed all areas and removed the old jointing. All surfaces were then treated with NCC Black Spot & Green Growth Remover to clean up these dirty areas and remove the unsightly growths and dark staining deposits from the natural stone slabs.

Although it was raining while CR Services were applying the new joint mortar, this was no problem as vdw 850+ unique jointing mortar is applied by wet-slurry techniques, meaning that during application the wetter, the better, so there was no disruption for the homeowner by having to wait for fine weather to re-book a fresh appointment.
