# Patio Refurbishment & All Paving Maintenance

### Porcelain Patio & Pathway, Knutsford, Cheshire

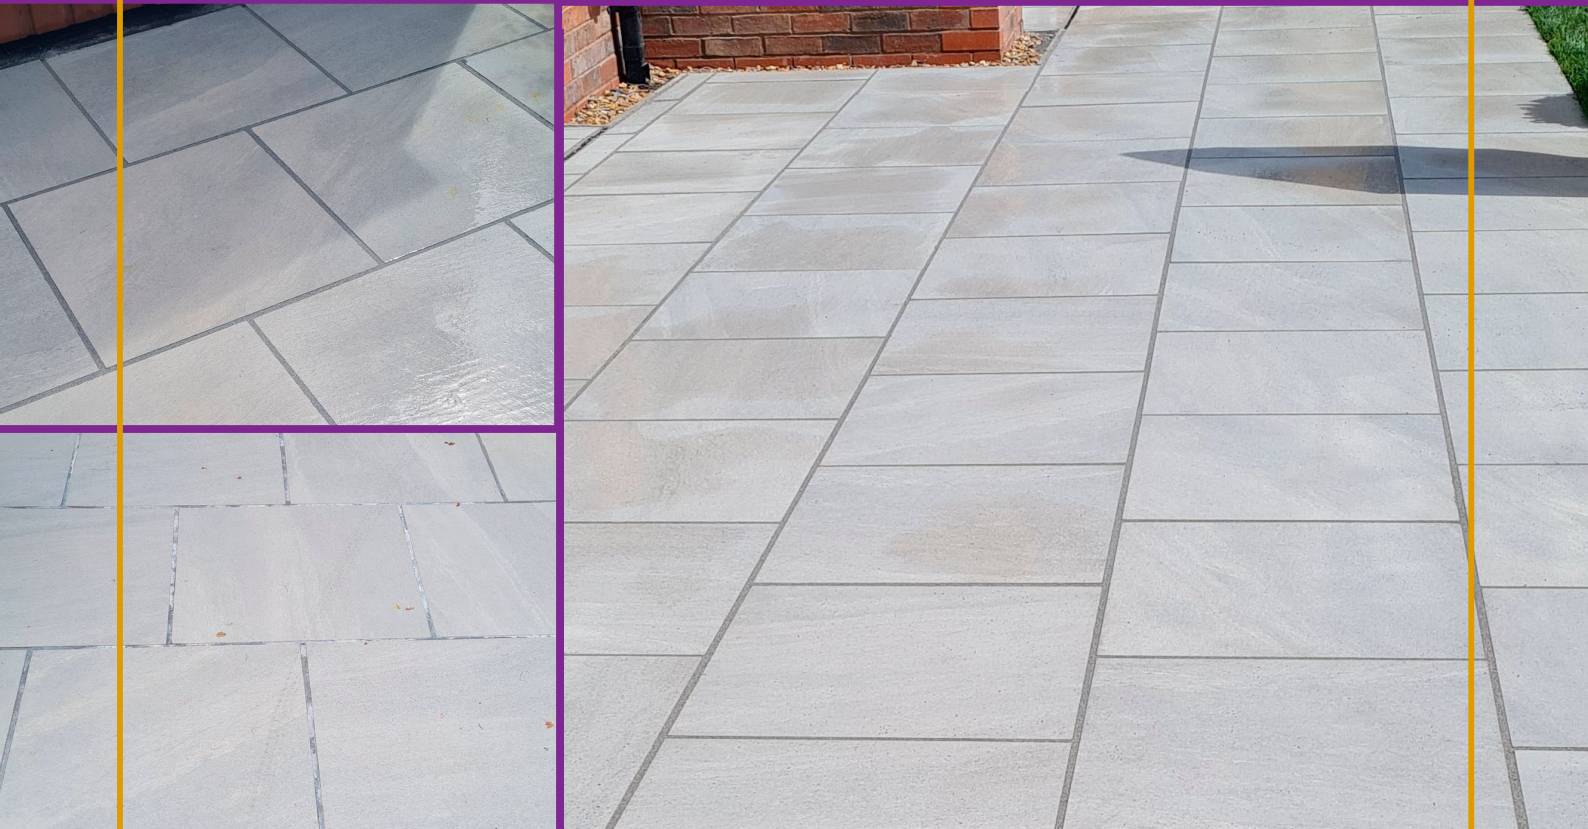
The homeowner of this property in Knutsford, was very proud of his porcelain tiled patio, which he regularly jetwashed to keep it clean and in pristine condition. Unfortunately, after only 18 months, he discovered that the original external tile grouting was not up to the job and that it was failing and being washed out, leaving unsightly gaps in many places. After extensive research, the owner contacted specialist paving contractors CR Services, and asked them for advice with regard to replacing the original pointing mortar with a tough and durable solution.

CR Services, together with their specialist material supplier NCC Streetscape, advised that GftK vdw 850+, an advanced, 2-part epoxy paving mortar was the ideal solution for this project with 6mm wide joints. GftK vdw 850+ paving mortar is non-staining, (staining is another problem when using cement based joint mortars), it can be regularly and safely jet-washed and can be installed in lower temperatures and wet weather - a huge advantage in the unpredictable British weather.

CR Services completed the refurbishment of the porcelain patio in very quick time. The homeowner was so delighted with the result, that he recommended CR Services to neighbours and family, who have since employed them to complete similar projects on their patios and paths.
