Patio Refurbishment & All Paving Maintenance

Case Study

Porcelain Patio & Pathway, Oldham, Greater Manchester

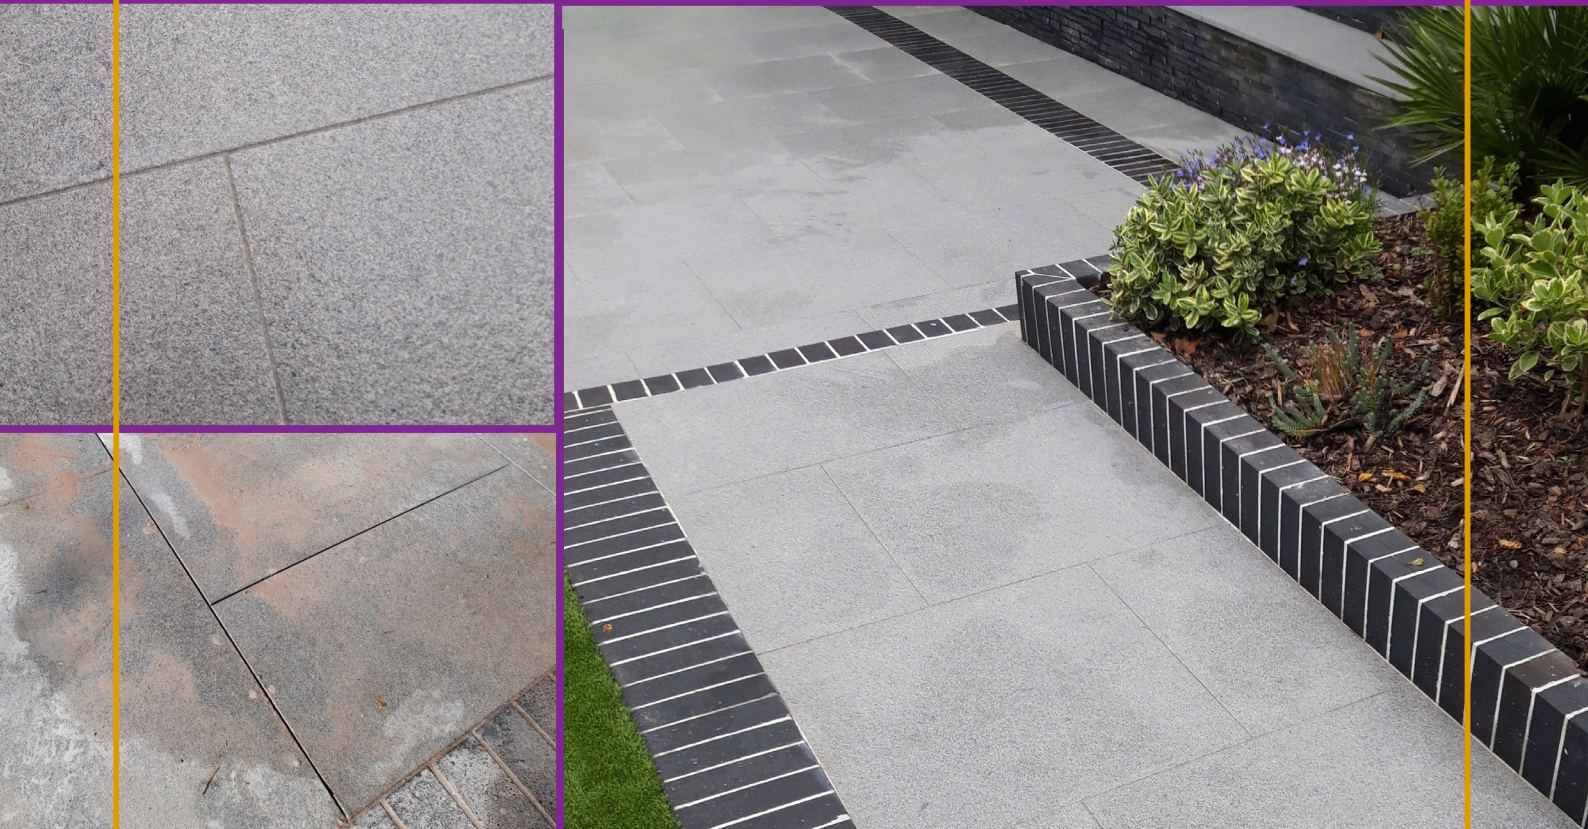
This beautiful porcelain patio in Oldham had only been down for 12 months, but already the paving joint compound (single-pack) used for the original job was failing. The narrow joints between porcelain slabs are not conducive to standard jointing mortars, and a product designed for porcelain and narrow joints is essential to obtain a tough, long-lasting result.

The owners contacted CR Services, who together with their specialist material supplier NCC Streetscape, advised that GftK vdw 815+, an advanced, 2-part epoxy paving mortar was the ideal solution to refurbish this project. It will not mark the porcelain as it is stain free, and it is specifically designed for use with narrow joints. This is a common feature on porcelain paving as the slab edges are cast to a very fine tolerance, thus allowing them to be almost butted up, to just a few millimetres (min 3mm advised), which gives a lovely clean appearance.

CR Services removed the failing grout and replaced it with vdw 815+, which is applied as a wet slurry, thus leaving no voids to weaken the integrity of the narrow joints.
