Patio Refurbishment & All Paving Maintenance

Case Study

Yorkstone Terrace, Macclesfield, Cheshire

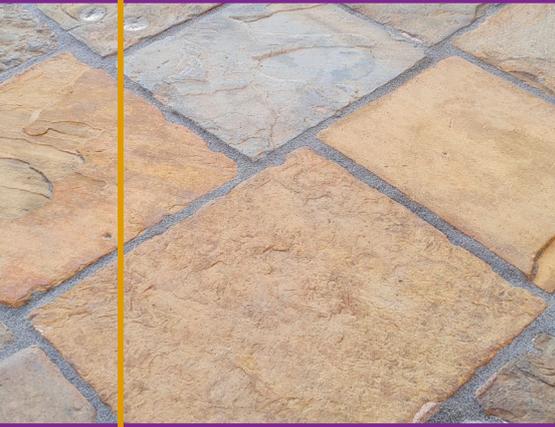
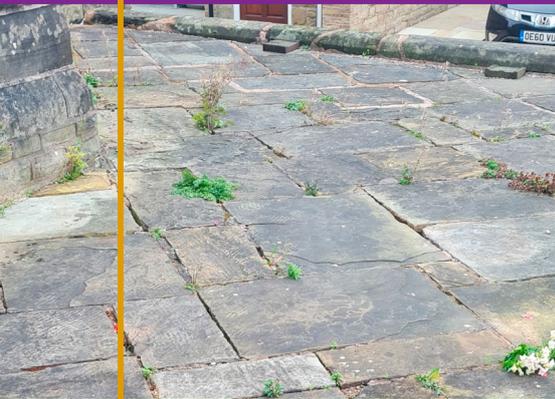
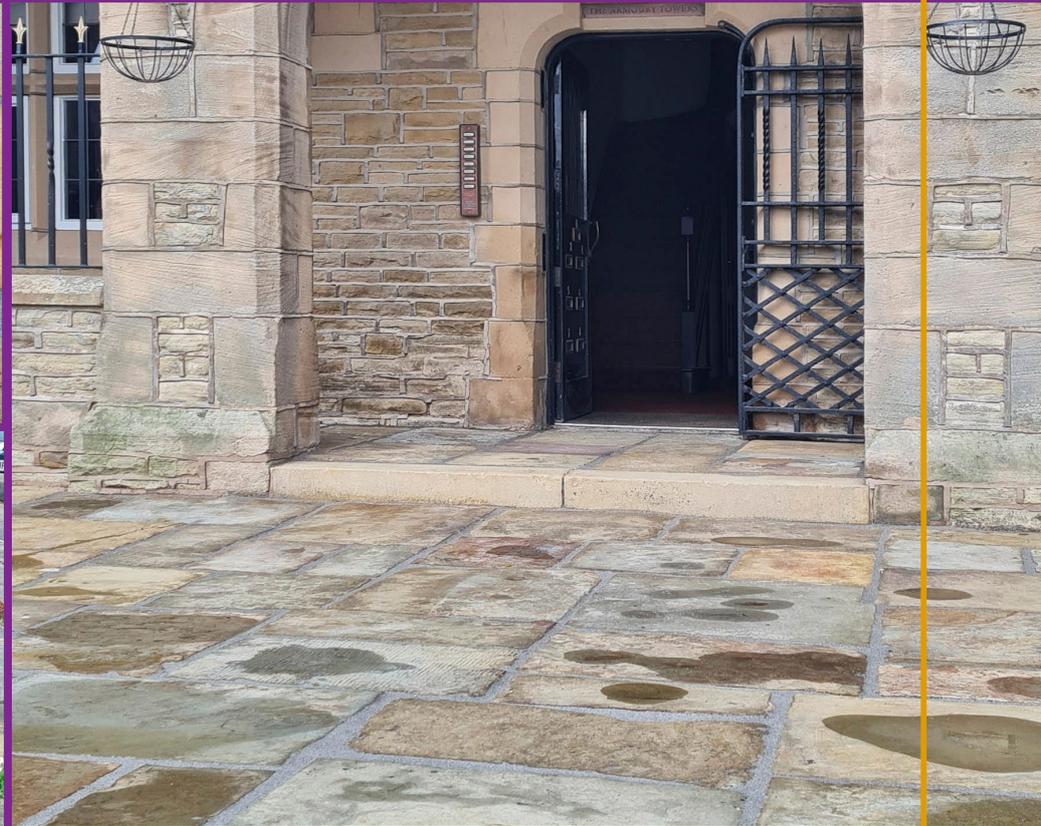
The predominantly Yorkstone paved terrace of this beautiful, listed building in Macclesfield was in desperate need of refurbishment. The jointing mortar was cracked and failing, the slab surfaces were stained and ingrained with dirt, and there was an abundance of green growth on the slabs and in the joints, as well as an extensive amount of difficult to remove, lichen 'black spots' in the pores below.

CR Services were consulted and they advised that GftK's vdw 850+ epoxy resin based, paving joint mortar from NCC Streetscape was the ideal choice to durably repoint the failed joints, especially as they had various widths and depths. This is typical with historic natural Yorkstone paving, which always leads to problems of shrinkage and cracking when using traditional cement-based joint mortars.

After remedial works to remove the old jointing, the paving was jet-washed and then the surfaces treated with high performance NCC Black Spot and Green Growth Remover, which does exactly what it says on the tin!

The non-staining, vdw 850+ is wet slurry applied by squeegee, and it effectively self-compacts into the varying width joints, enabling CR Services to complete the job in double quick time, with the terrace now looking as good, in fact better than new.
