Patio Refurbishment & All Paving Maintenance

Case Study

Khandla Sandstone Patio, Merseyside *'Still Perfect after 7 Years'*

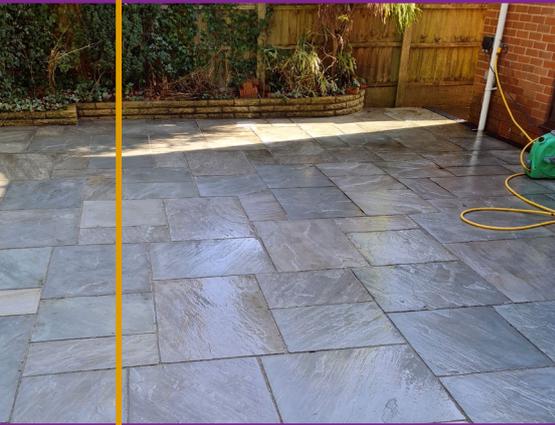
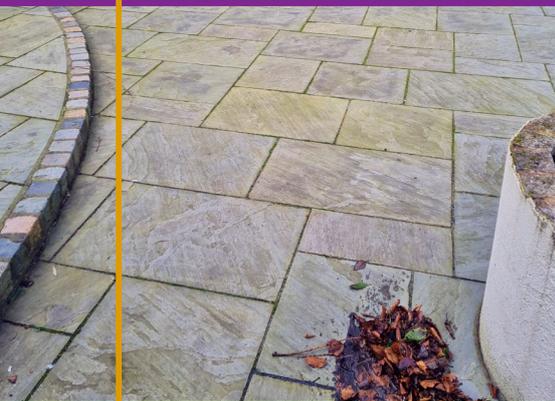
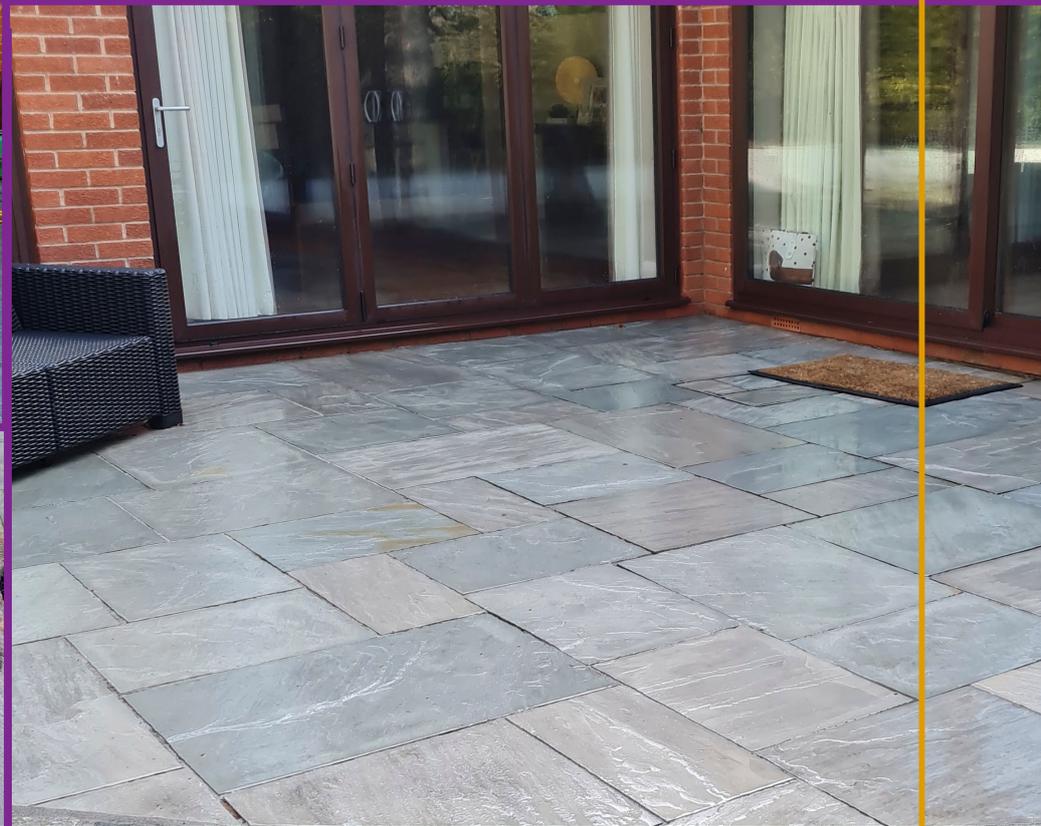
This natural Khandla Sandstone patio in Merseyside was laid new by CR Services, back in 2015, and grouted using a professional, high performance 2-part paving jointing mortar, which was supplied by NCC Streetscape. After seven years of frequent use for countless family events and frequent Alfresco dining, the paving and grouting were still sound and in perfect condition. However it had started to become unsightly with the surfaces needing a good clean, especially to remove green growth and hard to remove 'black spots', which are actually lichen deposits in the surface pores.

Having done such a good initial job, CR Services were contacted again by the owners and asked to advise on the best solution to clean, and then to undertake the works needed to restore the patios back to pristine condition. They recommended initial jet washing, followed by application of NCC Black Spot and Green Growth Remover, which does exactly as it says and removes unsightly green staining, as well as the difficult lichen blackspots.

Once again the homeowners are delighted with the work carried out by CR Services, and their Khandla Sandstone patio is back looking as good as the day it was originally laid - perfect again for those outdoor family events!
