# Patio Refurbishment & All Paving Maintenance

### Sawn Sandstone Patio & Pathway, Warrington, Cheshire

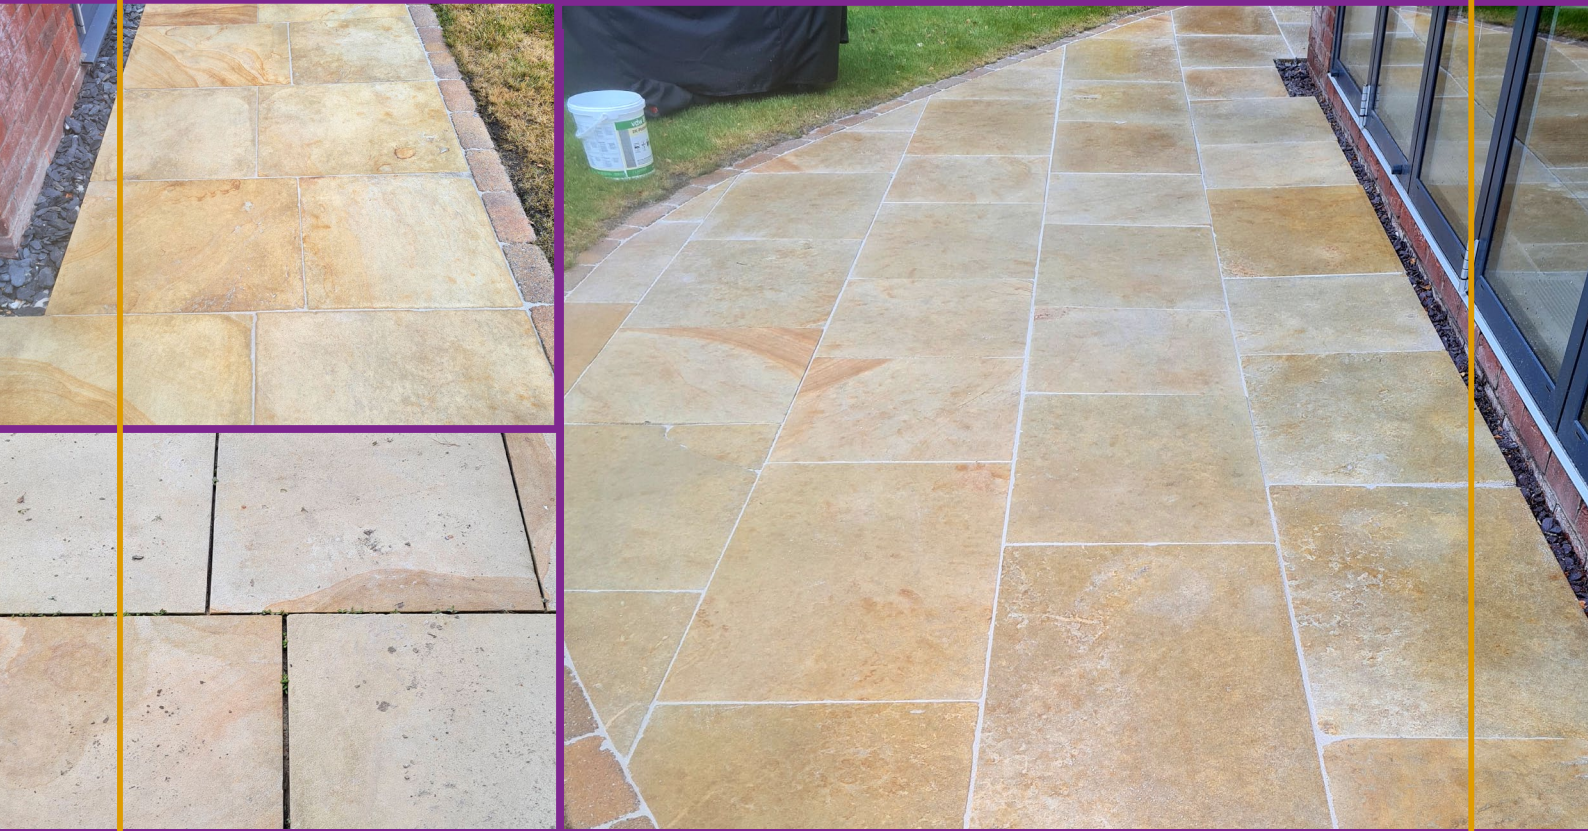
The sawn sandstone paving slabs used for the patio and pathways at this private residence in Warrington, enabled it to be constructed incorporating narrow 4mm joints, giving this natural stone patio a beautiful, clean appearance. Unfortunately, the single pack, 'standard' paving joint compound, that was used for the original pointing, had failed within the first 12 months.

Following online research, the homeowners contacted paving refurbishment specialists CR Services, who advised replacing the failed jointing with GftK vdw 815+, an advanced, 2-part epoxy paving mortar from NCC Streetscape. This was the ideal solution as GftK's vdw 815+ is stain free and is specifically designed to completely fill narrow joints, thus avoiding any voids forming that would threaten the structural integrity and lead to the joints failing.

Prior to grouting, the team from CR Services removed the failed grout and the patio slabs were jet-washed and thoroughly cleaned using NCC Black Spot & Green Growth Remover, to remove unsightly green staining and hard to remove lichen blackspot deposits.

The end result is a beautiful natural stone patio that is now tough and durable. It will withstand frost and jet-washing and last for many years into the future. Not just good as new, but better!
