Patio Refurbishment & All Paving Maintenance

Case Study

Riven Sandstone Patio & Terraces, Glossop, High Peak, Derbyshire

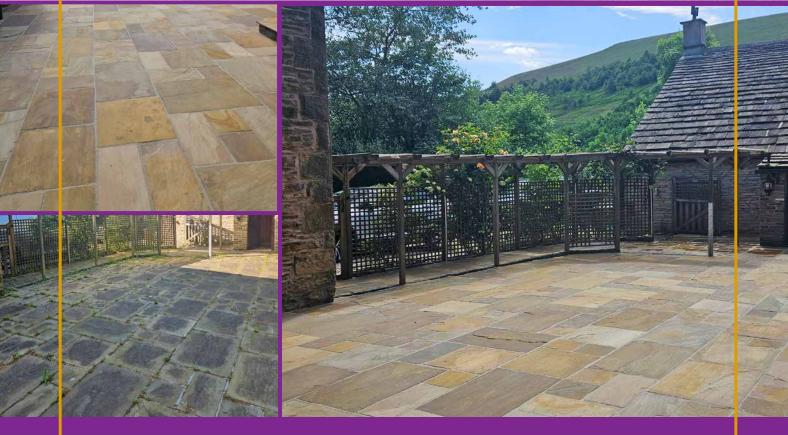
This charming old cottage, in Glossop, the High Peak district of Derbyshire, has 170m² of traditional old riven sandstone paving, not unlike Yorkstone. Some areas are also used as hard standing for motor vehicles.

The paving had been down for many years, and was in an extremely tired condition, with some missing slabs, old failed joint repairs, plus more cracked and failing sand and cement pointing. Together with dirt, grime, moss and lichen build up on the surfaces. the area was badly in need of TLC and refurbishment.

The team from CR Services first jet-washed and cleaned the area, using NCC Black Spot & Green Growth Remover, to remove dirt, grime and unsightly green stains, plus hard to remove black lichen spots. Loose slabs were reset with fast setting mortar, and any slabs that were missing were replaced with new reclaimed ones.

The team then repointed the area using GftK vdw 850+ in natural colour, a high performance, 2-part epoxy paving mortar, that is tough and durable. The homeowners can now safely use the area and without fear of damage from vehicle movements and regular jet-washing.
