# Patio Refurbishment & All Paving Maintenance

### Sandstone Patio, Alderley Edge, Cheshire

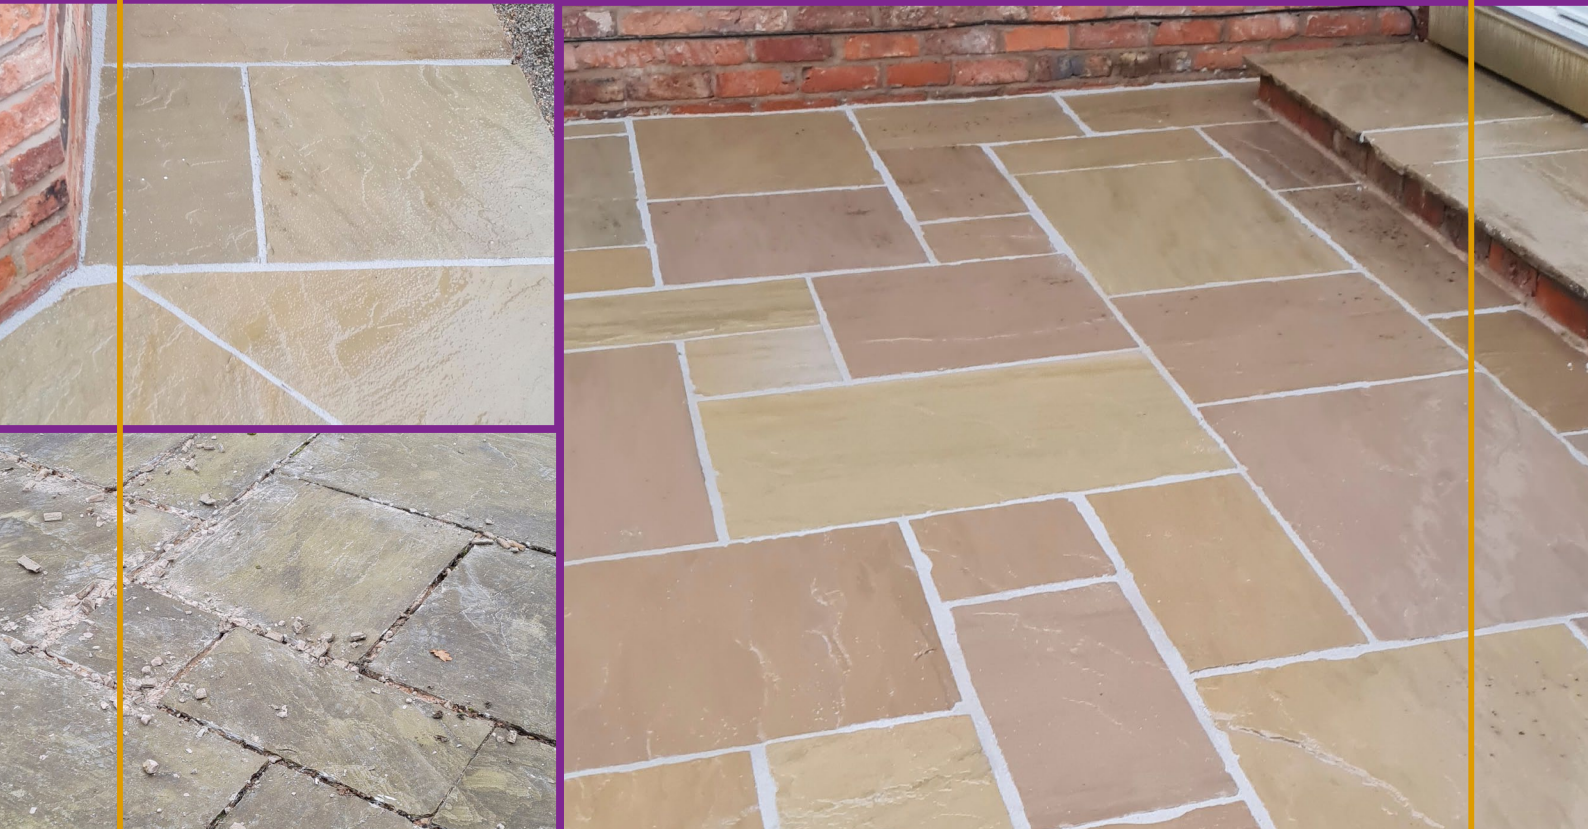
This private residence in Alderley Edge has a large sandstone patio and pathways covering an area of 180m<sup>2</sup>. Over the years these areas had become extremely dirty, with failed, sand and cement ointing, together with unsightly dark staining deposits on the natural stone slabs. The homeowners decided it was time to give the patio and pathways some care and attention and bring them back to their original beauty. They contacted specialist paving contractors CR Services who had successfully completed many such projects in the area.

CR Services recommended GftK's vdw 850+, which is a non-staining, 2-part epoxy paving joint mortar, supplied by NCC Streetscape, that is ideal for all types of natural stone paving. It is applied by wet slurry techniques, and will harden even in the cold and wet, so no delays in working due to inclement weather.

Prior to grouting, all areas were jet washed, the old failed cement jointing mortar was raked out and any green growth and black lichen spots were removed using NCC Black Spot and Green Growth Remover.

The crew from CR Services completed this large project quickly and efficiently, leaving the owners delighted with their patio which was now back looking not only as good as new, but in fact better with GftK high performance professional jointing.
