# Patio Refurbishment & All Paving Maintenance

### Sandstone Patio & Pathways, Nantwich, Cheshire

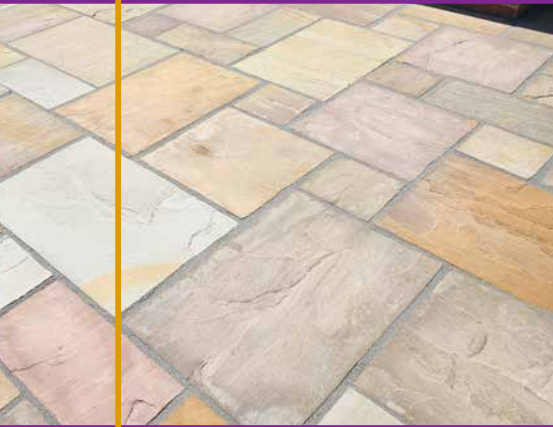
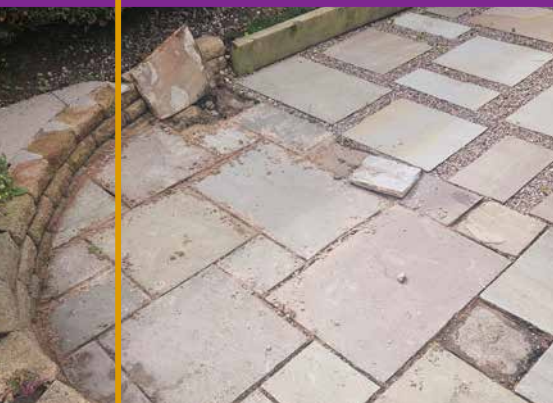
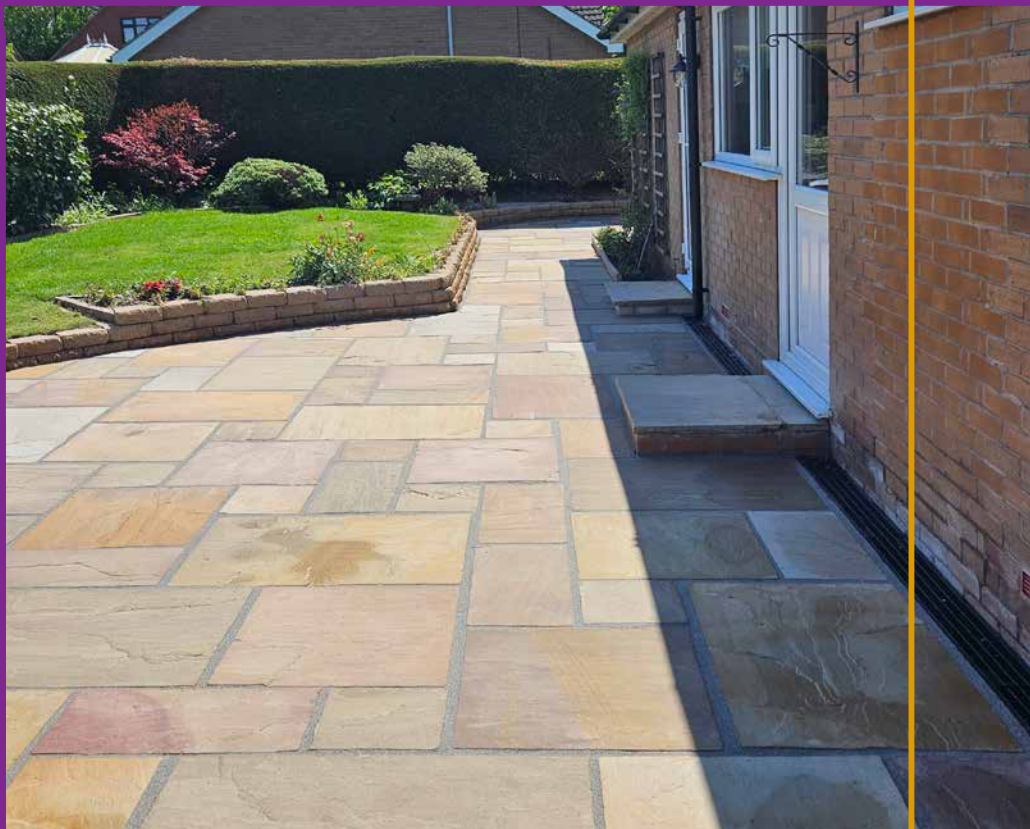
This patio at a private residence in Nantwich, Cheshire was 10 years old and badly in need of refurbishment. The original sand and cement jointing was cracked and failing, and the paving slabs were discoloured, with a few slabs debonded. An earlier attempt to repoint the failed joints with more sand and cement had been unsuccessful, and as a result, the patio area paving was spoiling an otherwise well maintained garden.

Specialist paving contractor CR Services was approached by the homeowner who immediately knew the solution: Remove the old jointing and reset loose paving slabs with rapid setting mortar, then jet-wash and thoroughly clean with NCC Grime Remover, a heavy duty surface cleaner.

For the repointing, CR Services used GftK's vdw 850+ in stone grey, a tough, non-staining, 2-part epoxy paving mortar, supplied in the UK by NCC Streetscape. This high performance mortar is ideal for all types of paving and a big advantage for home owners in the UK is that it can be applied in inclement weather, so no waiting around for a fine day!
