Patio Refurbishment & All Paving Maintenance

Case Study

Indian Sandstone Patio, Warrington, Cheshire

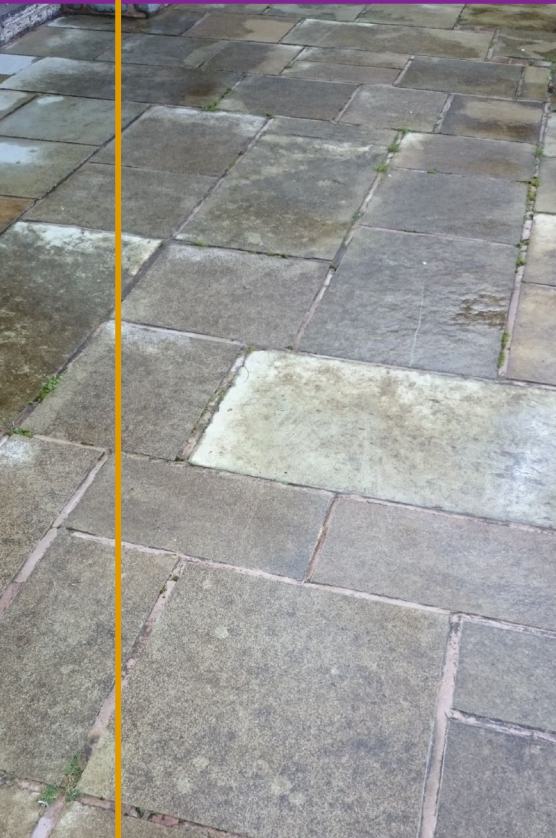
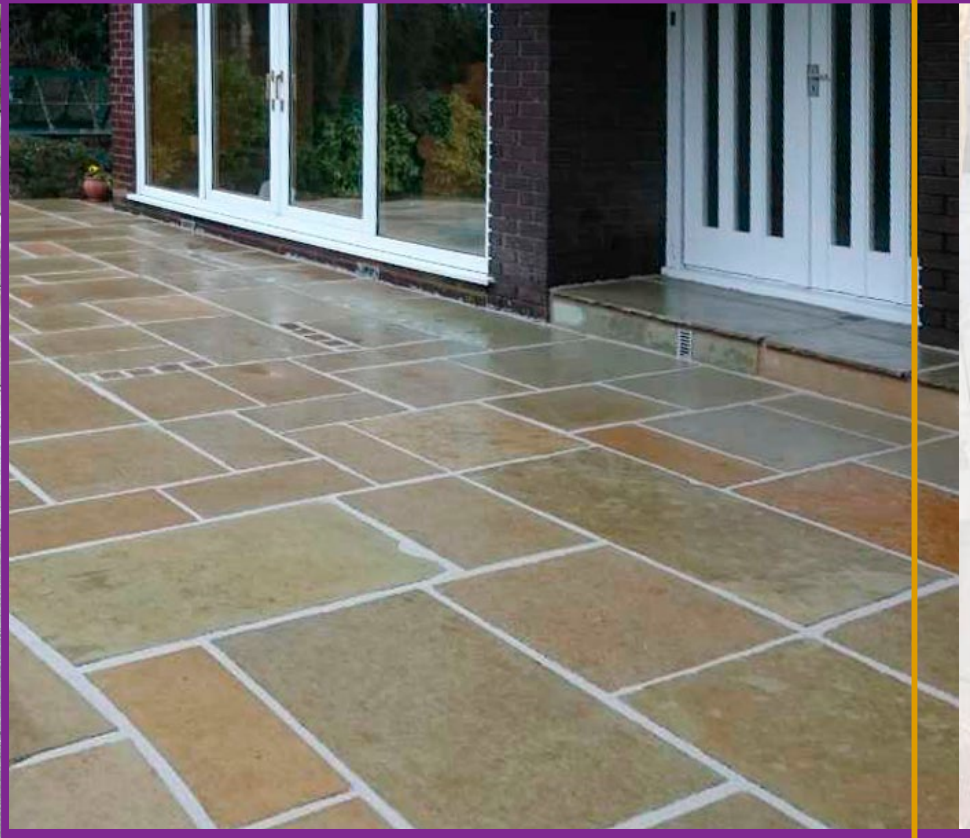
Over the years these owners had had continuing problems with their beautiful terraced patios and pathways, all built in an attractive light coloured, natural Indian Sandstone. Unfortunately, the original traditional site-produced, sand and cement pointing had soon failed and then been repaired, this time with prebagged cement based jointing mortar.

However this had also failed and started to break up and fall out within a short period of time – and for the same reasons - sand and cement pointing is very sensitive to the vagaries of British weather.

After a thorough clean with NCC Black Spot & Green Growth Remover, the skilled team from CR Services re-grouted the patio using GftK's vdw 850+, a professional 2-part epoxy mortar supplied by NCC Streetscape that is not weather dependent for placing. The homeowners can now safely jetwash their patio without fear of failure.
